**US Army Corps
of Engineers**

USACERL Technical Report 96/77
July 1996

Investigation of Preapproved Underground Heat Distribution Systems

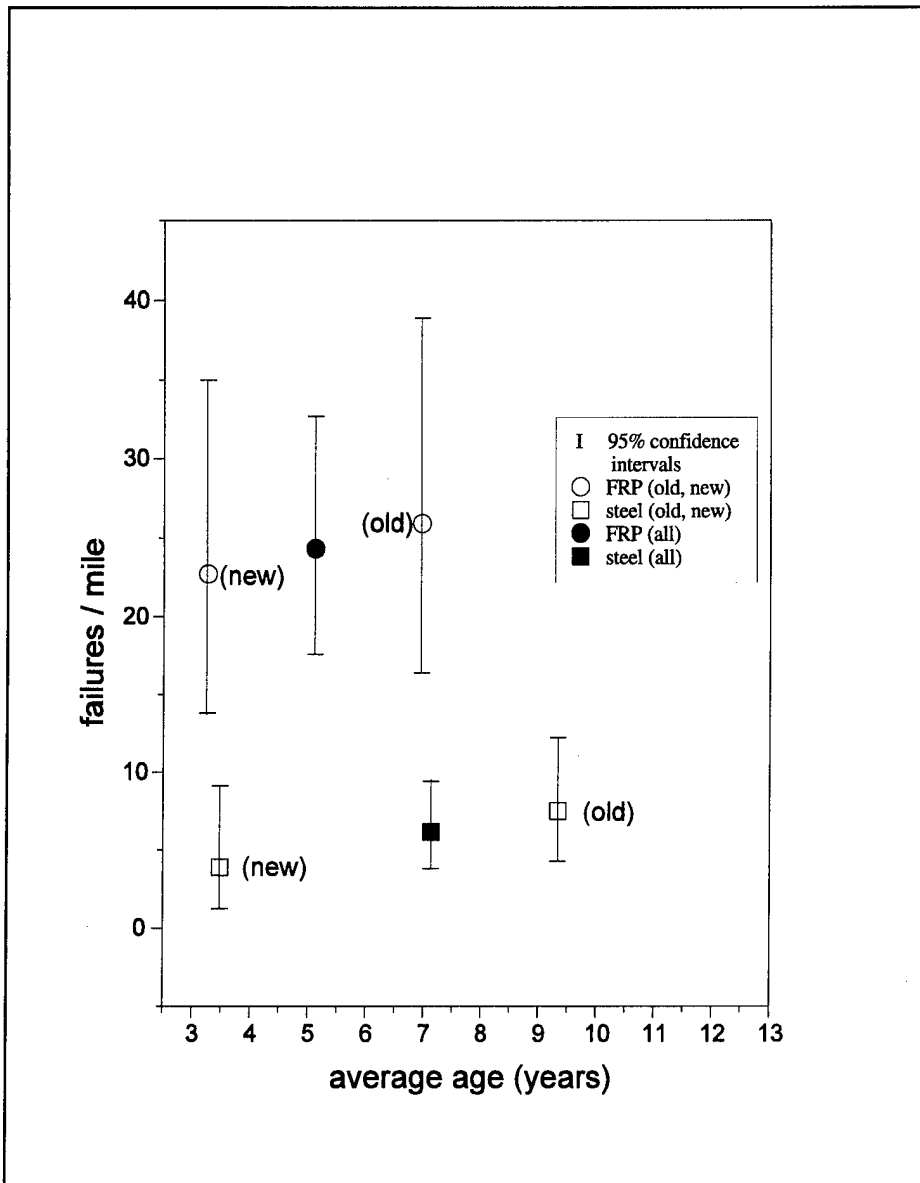
Figure 1a. Failure rates vs. age (Standard I).

However, plotting the results in Tables 11 and 12 may show the general time dependence of the failure rates (Figures 1a and 1b). Accounting for the confidence intervals, the time dependence of the failure rates are not pronounced. The failure rate for FRP conduits appears to decrease slightly as the systems get older. The failure rate for steel appears to increase marginally. However, it would be difficult to call these trends statistically significant.

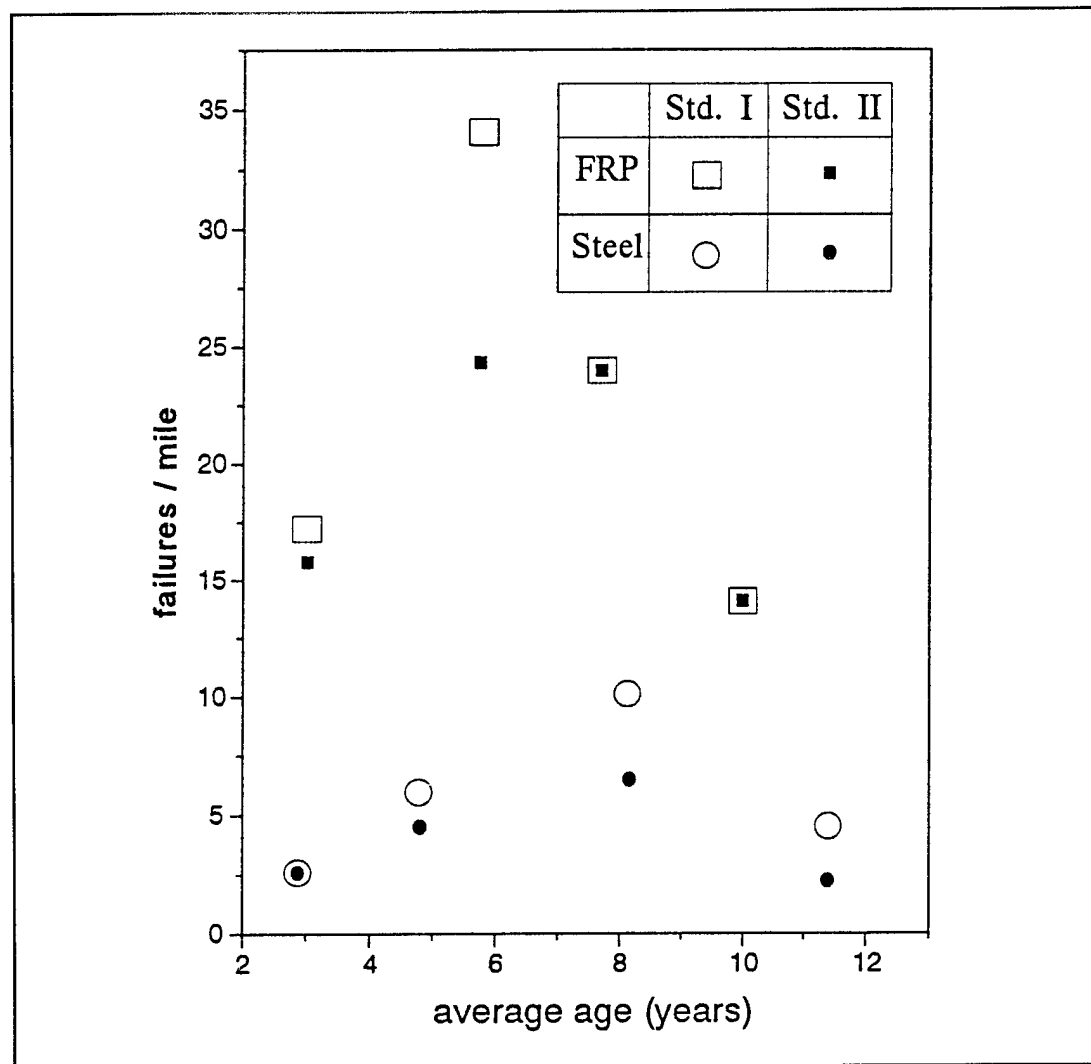
Figure B1. Failure rates versus length-weighted average age for four sequential time periods.

The Pearson correlation coefficient between failure rate and age was found to be quite small ($R^2 \leq 0.1$). A generalized linear model was fit to the data, attempting to explain variation in failure rates with material type (represented by an indicator variable) and

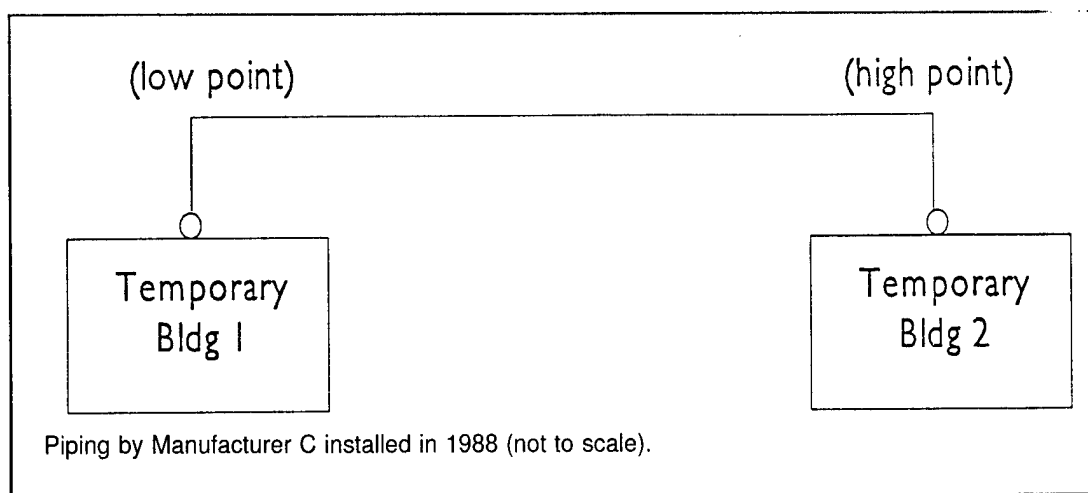
Figure D2. Schematic diagram of System 4 at Wright-Patterson AFB, OH.

This system consists of piping from Manufacturer C and has a steel conduit (Figure D2). It was installed in 1990 under contract No. F33601-89-CW027. The project consists of steam and condensate lines contained in a single conduit. It ties into an

overhead system, feeds two temporary buildings along "L" street and extends approximately 600 ft. On the lower half of the system, the route of the conduit and expansion loops were clearly defined by dried grass over the buried conduit.

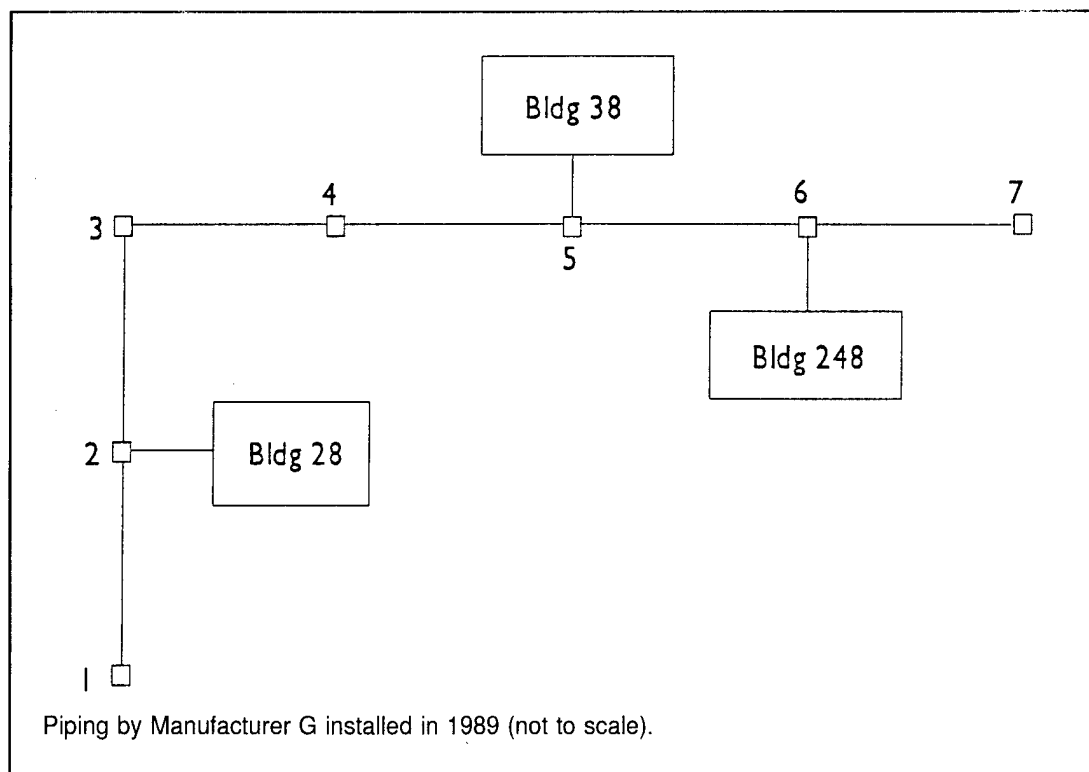
Figure D3. Schematic diagram of System 5 at Wright-Patterson AFB, OH.

This system consists of piping from Manufacturer G and has an FRP conduit (Figure D3). Drawing WP-43-7 for the project was dated May 1989. The contract involved replacing condensate lines using new vinyl ester resin conduits and steam lines

encased in conduits of the old polyester resin. The "L"-shaped system runs parallel to Buildings 28 and 38. It then makes a right angle to run along the end of Building 28. Manholes 6 and 7 were in a construction zone and were inaccessible.

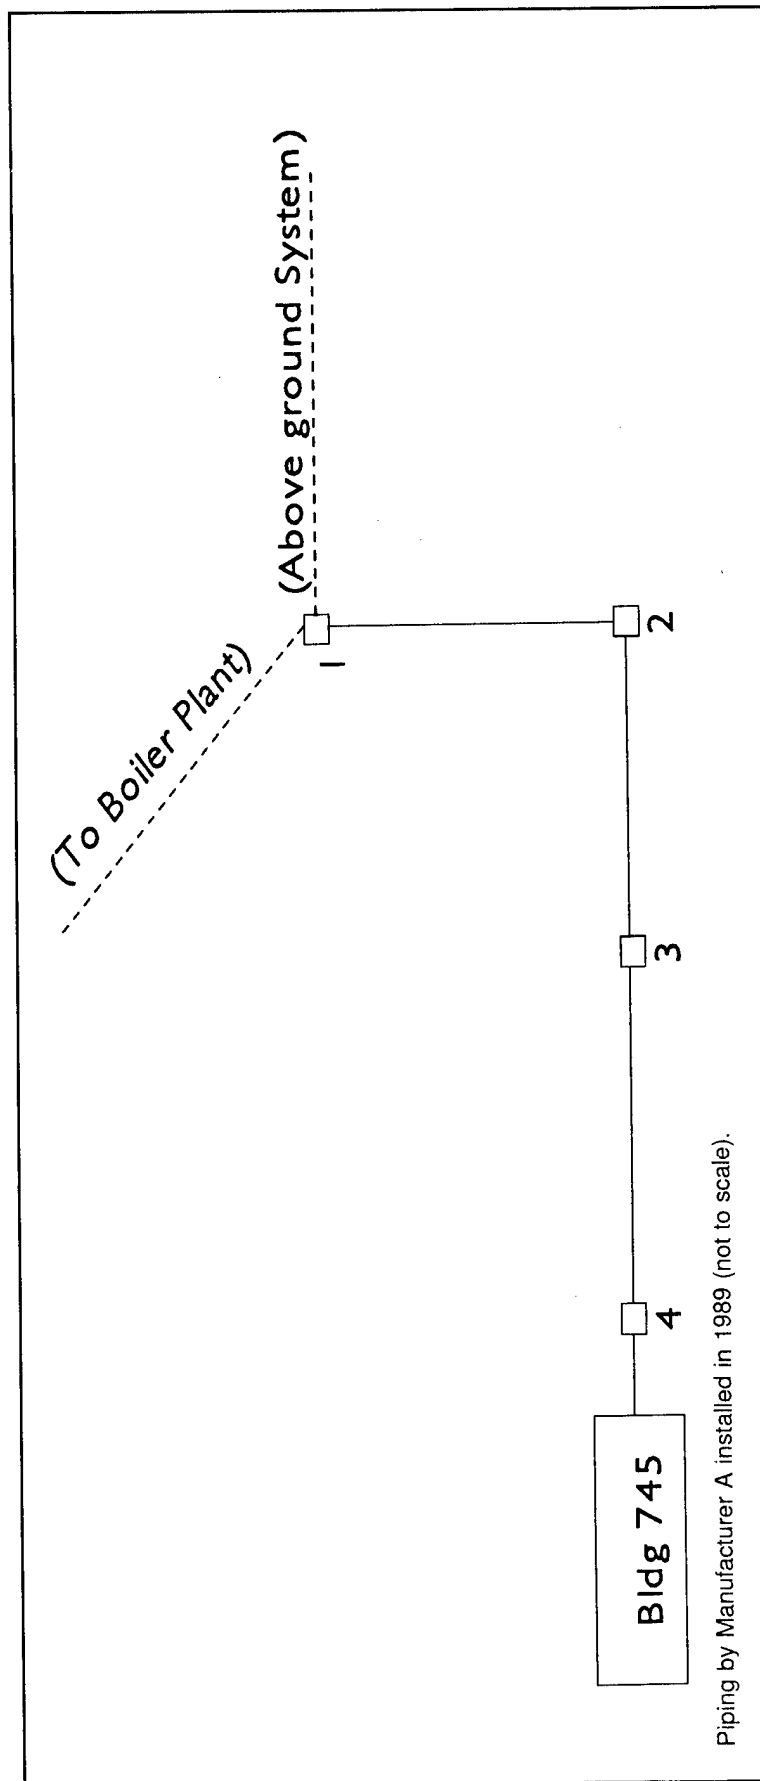
Figure D5. Schematic diagram of System 7 at Wright-Patterson AFB, OH.

8. Detailed Inspection of System #7—This system consists of piping from Manufacturer A and has a steel conduit (Figure D5). The 1989 project was designated WP 54-8, FAC. 07199, and PCF1939. The piping was at the base of a long sloping hill.

The system was fed from the boiler plant (Building 770), has four manholes, and serves Building 745. Rain precluded pressure testing.

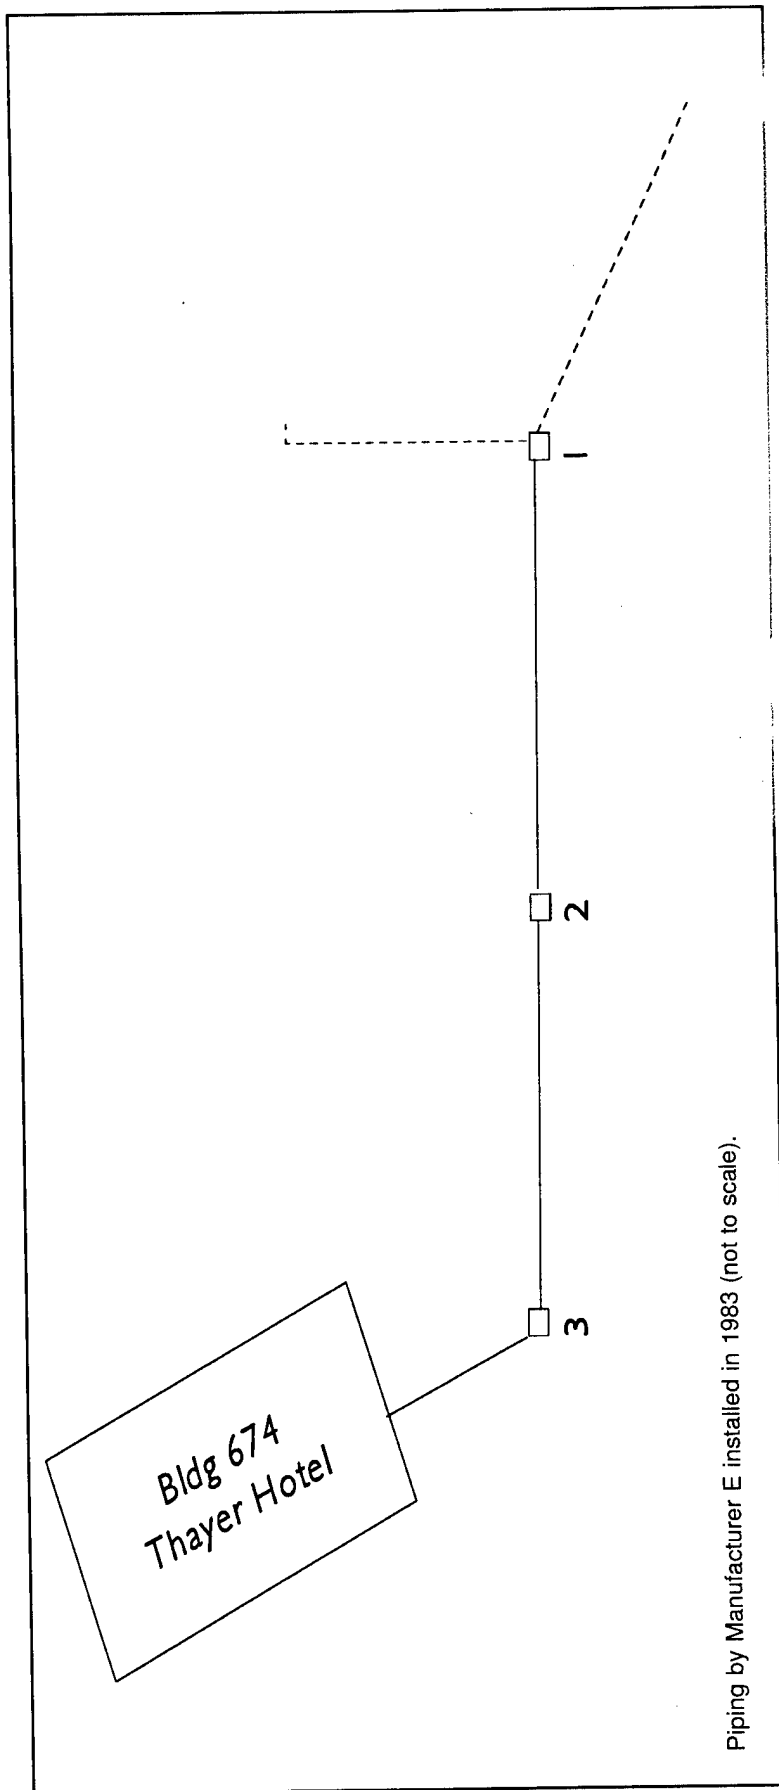
Figure F1. Schematic diagram of System 10 at USMA, West Point, NY.

a. Manhole 1—This manhole was 18 ft × 12 ft × 8 ft deep, was of the solid concrete top design, and had two 3 ft × 2 ft steel plate access hatches. The manhole was served by a steam ejector type sump pump. Steaming was observed from a 6-in. manhole vent pipe. This steaming was caused by a 1-in. discharge line from pressure regulating station relief valves being routed out of the vent pipe. The manhole was dry. Wall penetrations consisted of neatly drilled holes in the manhole walls for the installation of link seals between the conduit casings and the concrete. No conduit vents or drains were observable on runs from Manhole 2 because the end plate assemblies were buried outside of the manhole.

b. Manhole 2—This manhole was 6 ft × 9 ft × 8 ft deep, was of the solid concrete top design, and had a 3-ft-diameter steel manhole cover and an 18-in. steel covered

inspection port. No sump pump or means for ventilation were provided, and 3 in. of standing water was present. Link seals were used between the end plates and the heat carrying pipes. The conduit vents and drains were 3/4-in.-diameter instead of the required 1 in. The drains were fitted with check valves that did not function properly in this application after a time. None of the five conduit vents were observed to be steaming. Three drains were checked and were dry.

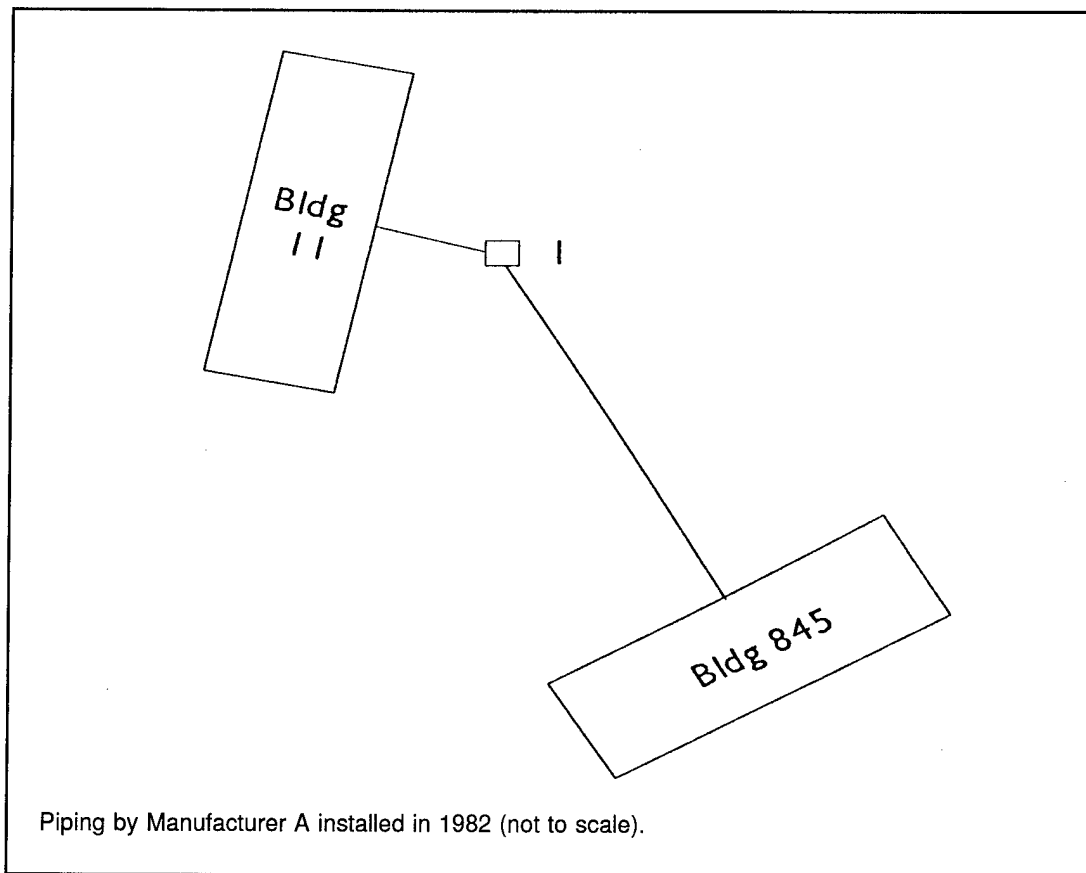
Figure I1. Schematic diagram of System 14 at Jacksonville NAS, FL.

This system consists of piping from Manufacturer A and has a steel conduit (Figure I1). The project, designed in 1982 by Architect-Engineer Evans and Hammond of Jacksonville, FL, was "Replacement of Steam Condensate Lines," Construction Contract N62427-2514 (Spec. 06-82-2514). This system is above ground except for street crossings and for service to Buildings 11, 845, and 855. Manholes were not provided at street crossing segments.

a. Transition Southeast of Building —Two side-by-side manholes are at the point where the above ground system transitions to below ground. Manhole A (7 ft x 7 ft x 5 ft deep) appeared to be part of an older system that was in use prior to 1983. The manhole top was covered with removable steel plates with no manhole vents. The manhole contained no sump pump and was dry. A 6-in. steam line and a 4-in. condensate line exited the manhole through a buried concrete trench. Maintenance personnel indicated that the 4-in. line has been abandoned and that the 6-in. line was being used for condensate return. The temperature of the 6-in. line was 170 °F. There

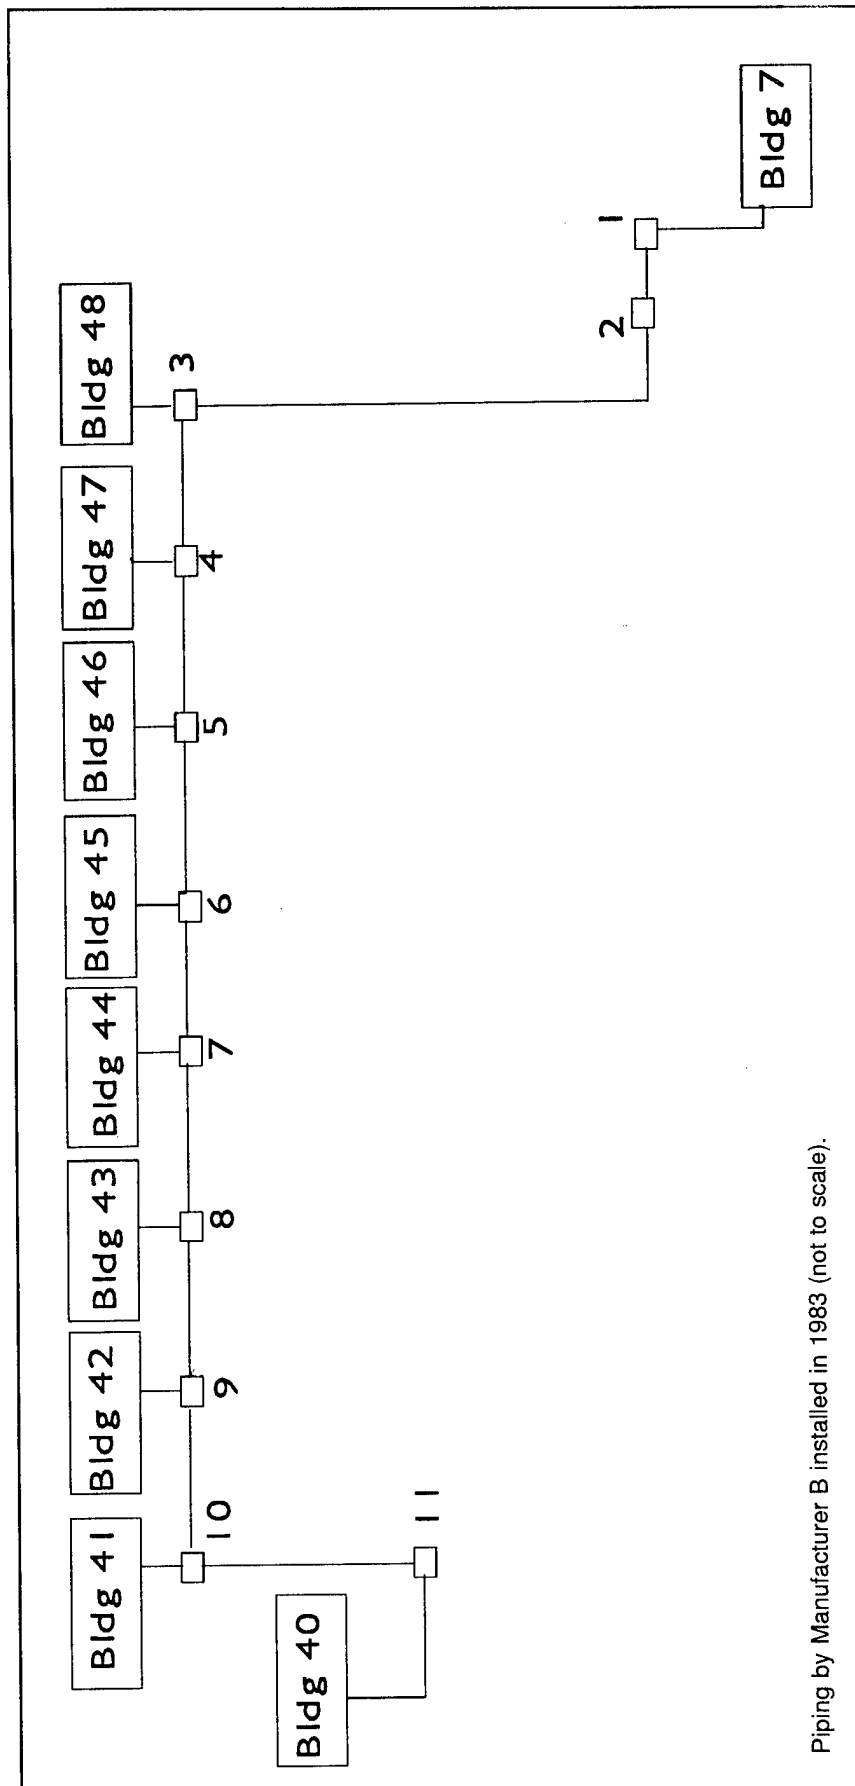
Figure J1. Schematic diagram of System 20 at Mayport Naval Station, FL.

a. Manhole 1—This manhole was 8 ft × 5 ft × 10 ft deep and was northwest of Building 7. The manhole had removable heavy steel plate tops with no manhole vents. No entry ladder was installed. Water in the manhole indicated that the steam jet sump pump was not operational. The 6-in. steam line was contained in a 13-in. conduit. A gland seal was installed at the conduit end plate. The manhole was extremely hot and could not be entered.

b. Manhole 2—This manhole was essentially identical to Manhole 1.

c. Manhole 3—The conduit run from Manhole 2 was approximately 1,200 ft under a street and a large paved area. The manhole top consisted of two heavy steel plates with no vent pipes located below grade. The manhole walls did not extend above grade and surface water tended to collect in the depression. The manhole was steaming heavily and could not be opened for inspection.

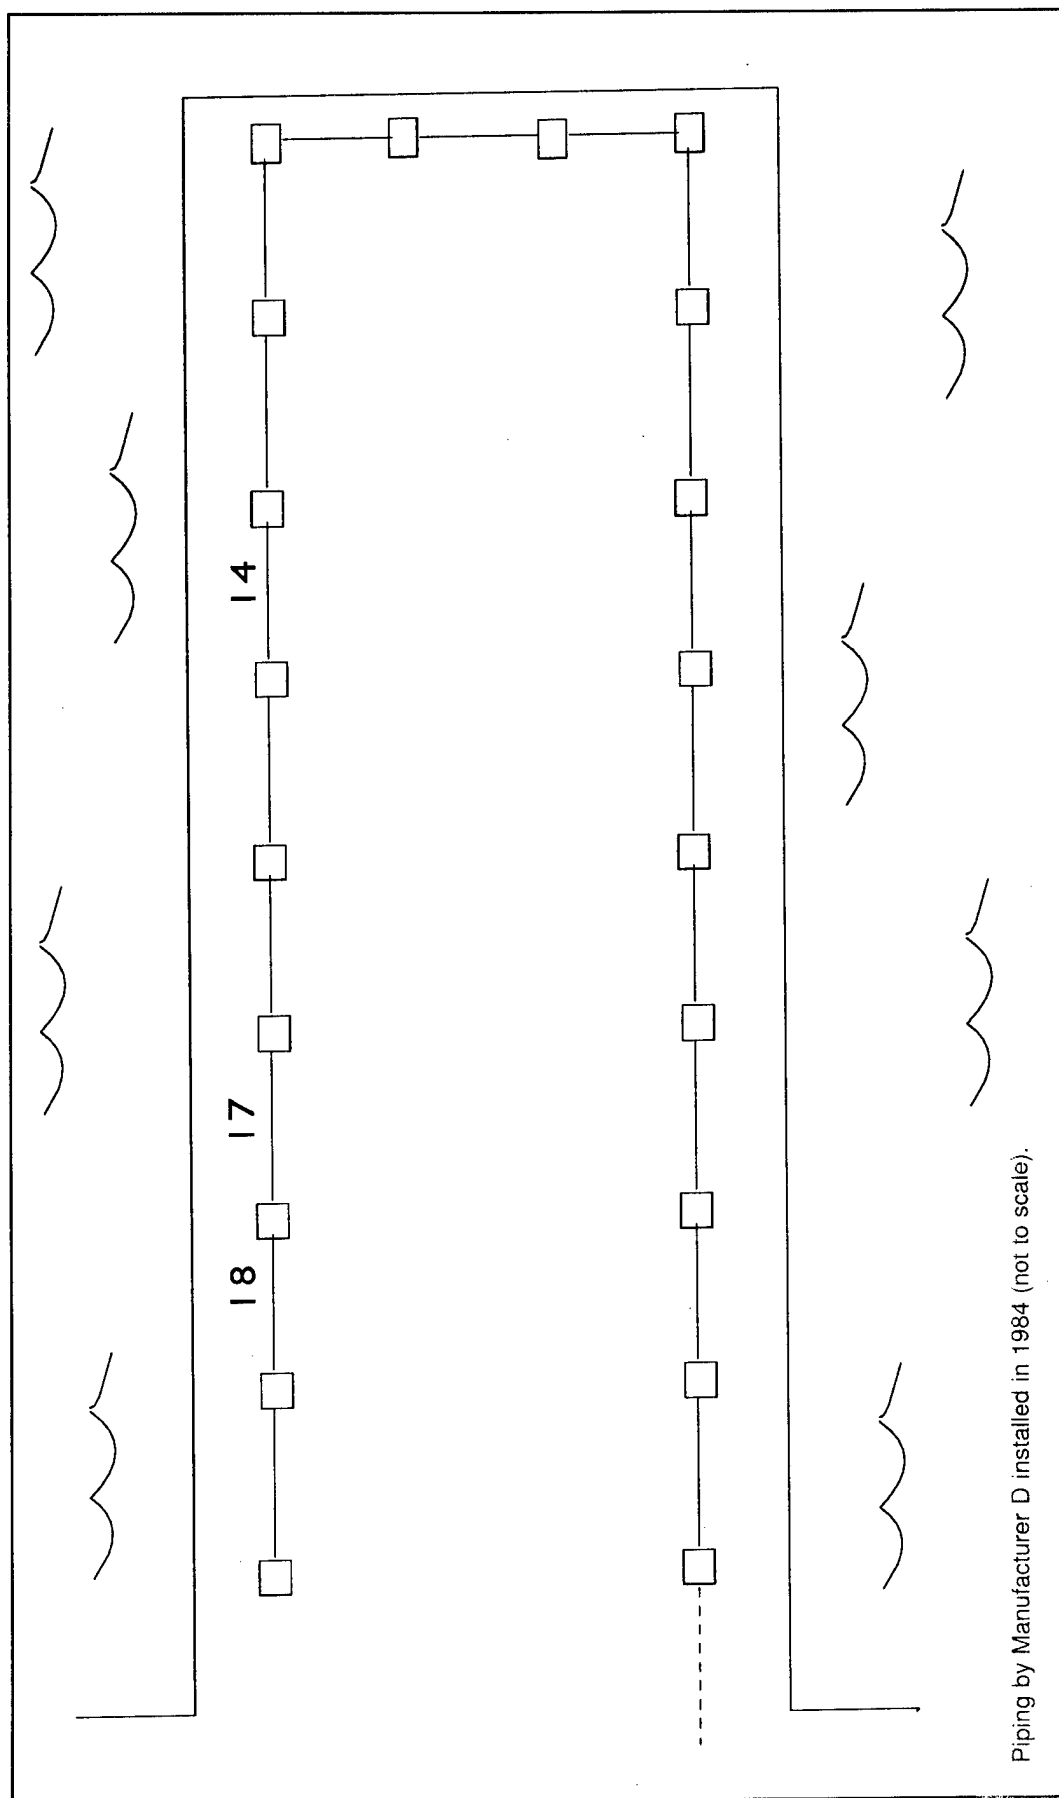
Figure K1. Schematic diagram of System 22 at Charleston Ship Yard, SC.

a. Pressure Test of Conduit Section 18—This conduit section was 226 ft long. Air pressure was initially applied at 3:00 PM. Significant air leakage occurred at both gland seals. One gland seal was effectively tightened, while the other seal had a broken bolt and a second bolt that could not be reached. Some leakage remained at the latter gland seal. The conduit was again pressurized and valved off at 3:12 PM. The pressure readings and times observed were:

b. Pressure Test of Conduit Section 17—This conduit section was 158 ft long. The conduit and end plate coatings were in excellent condition. No steaming or moisture occurred at the vent and drain at the higher elevation. At the lower elevation, a large quantity of water was drained from the conduit. The manufacturer's representative theorized that this moisture had been absorbed by the calcium silicate insulation, was later driven off when the system was energized, and then condensed in the conduit casing. The conduit was pressurized to 15.5 psi and valved off at 9:27 AM. The pressure readings and times observed were:

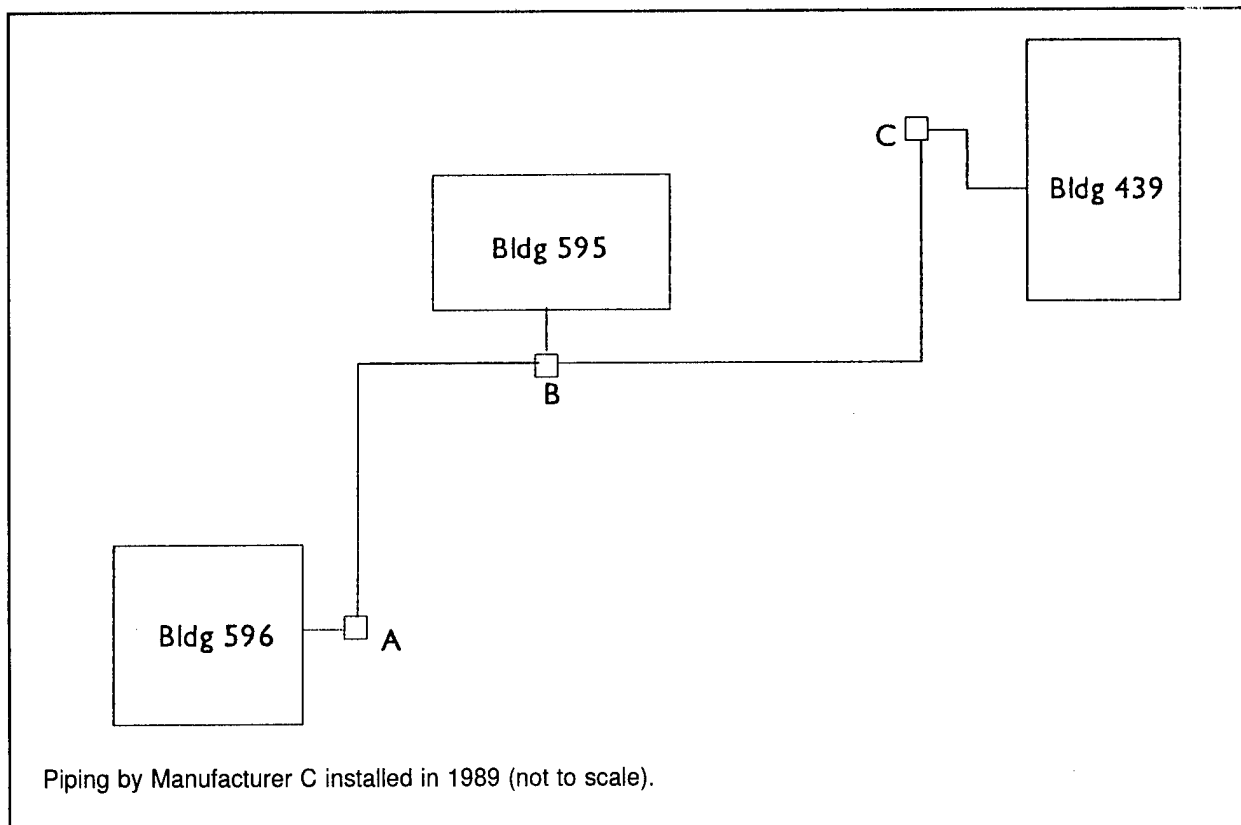
Figure M1. Schematic diagram of System 24 at Grissom AFB, IN.

This system consists of piping from Manufacturer C and has a steel conduit (Figure M1). It was installed in 1989.

a. Pressure Test 1— This section extended 20 ft from Manhole A to a pit in the equipment room of Bldg. 596. The concrete manhole was 5.5 ft × 5.5 ft × 6 ft deep, extended slightly above grade and had a solid aluminum plate cover. No access ladder was present and a steam valve gasket had a slight leak. Six in. of water in the manhole was drained after adjusting the float mechanism on the sump pump. The conduit wall penetrations were caulked and cemented. No vapor was evident at the steam line casing vent, but a light dripping was noted at the drain opening. Gland seals were installed at the end plates both at the manhole and the building pit. Building pit dimensions were 4 ft × 4 ft × 5 ft deep. The steam line casing was 10-3/4 in. in diameter and contained a 3-in. pipe.

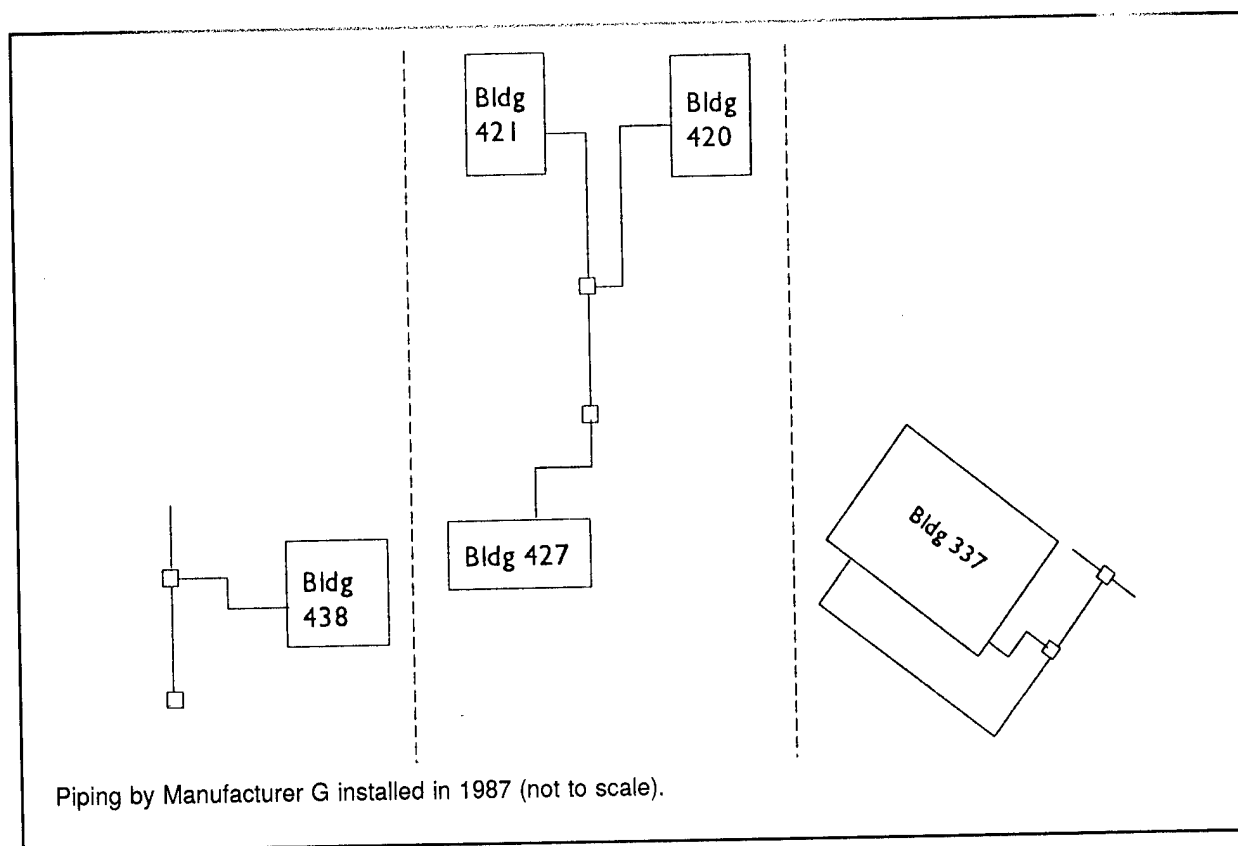
Figure M2. Schematic diagram of System 25 at Grissom AFB, IN.

b. Pressure Test 3—Conduits extend 200 ft from Manhole E at northwest corner of Bldg. 427 to Manhole F feeding Bldgs. 421 and 420. Both manholes were concrete with solid plate aluminum covers and caulked and cemented conduit wall penetrations. Manhole E was 10 ft x 5 ft x 10 ft deep, and Manhole F was 10 ft x 5 ft x 8 ft deep. Manhole E had a leak at the steam water ejector. No gland seals were present

at conduit end plates. The 12-in.-diameter steam supply casing contained a 3-in. steam pipe and the 6-in.-diameter condensate casing enclosed a 1-1/2-in. return line.

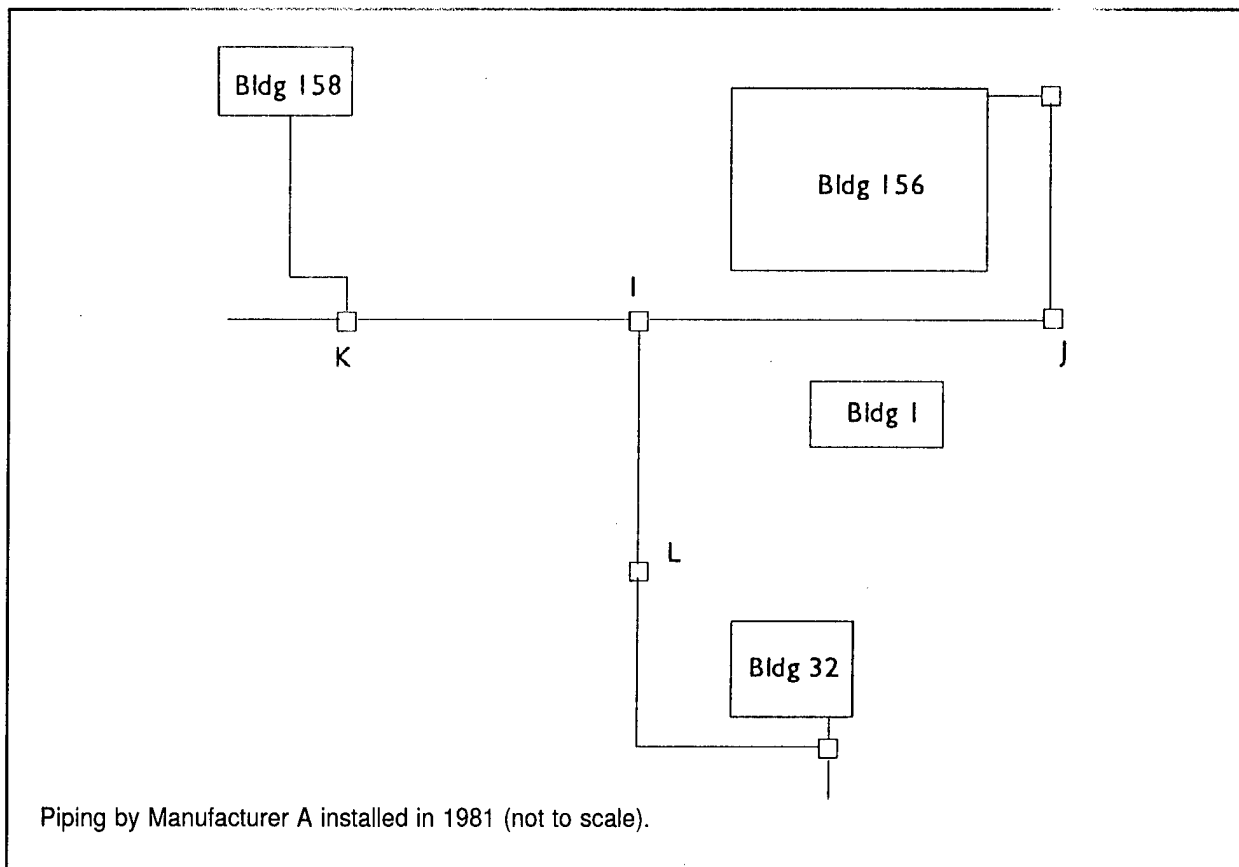
Figure M3. Schematic diagram of System 26 at Grissom AFB, IN.

11:13 AM — 15.0 psi
11:18 AM — 15.0 psi
11:23 AM — 14.8 psi
11:28 AM — 14.0 psi
11:33 AM — 13.5 psi
11:38 AM — 12.8 psi
11:43 AM — 12.2 psi
11:48 AM — 11.8 psi

(2) Pressure Test 2 (Condensate Return)—The condensate conduit casing was pressurized to 14.0 psi at 10:10 AM and exhibited no pressure loss through 10:40 AM, when the test was terminated.

b. Pressure Test 3—Conduits extended from Manhole I, described above, to Manhole K—a distance of 400 ft. Manhole K was 5 ft × 10 ft × 7 ft deep with an open grate top. Water was pumped out of the manhole after adjustment of the sump pump float mechanism. There was heavy water infiltration into the manhole at a conduit wall penetration. The 20-in.-diameter steam conduit casing contained a 10-in. steam pipe. The 12-in.-diameter condensate conduit casing contained a 4-in. return line.

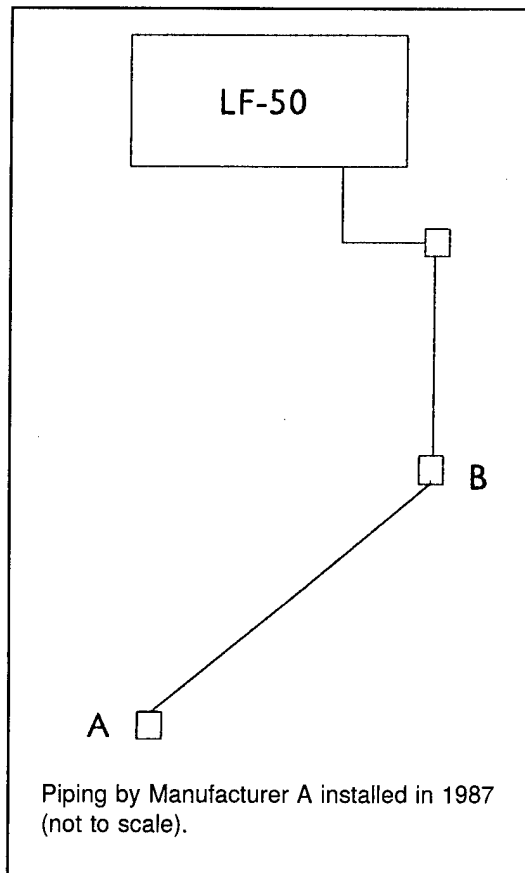
Figure N1. Schematic diagram of System 27 at Norfolk Naval Station, VA.

Pressure Test—This conduit section extended from Manhole A at the intersection of Toway and Avionics streets under Toway northward to Manhole B south of Building LF-50. The distance between manholes was 200 ft. Manhole A was in a parking area and was constructed of concrete with a solid concrete top flush with the pavement. The top contained 36-in.- and 24-in.-diameter access holes with steel plate covers. No manhole ventilation was provided. Manhole dimensions were 12 ft × 8 ft × 7 ft deep. A slight steam leak was present at the steam ejector sump pump. The heat carrying pipe had no insulation. Wall penetrations were caulked and cemented. Manhole B was concrete with walls extending about 1 ft above grade. The solid concrete top contained two access openings and two 6-in. vent pipes. Manhole dimensions were 9 ft × 12 ft × 8 ft deep.

Some minor leakage was observed at the steam ejector pump, but the manhole was dry. Manhole A was drained of water with a portable pump, and both manholes were cooled with portable fans. The conduit casing was 12-in. in diameter and contained a 3-in. steam line. A gland seal had been installed at the conduit entry in Manhole B. Pressure was applied to the conduit at 11:59 AM, but the pressure would not rise above 5 psi. Pressure readings were as follows:

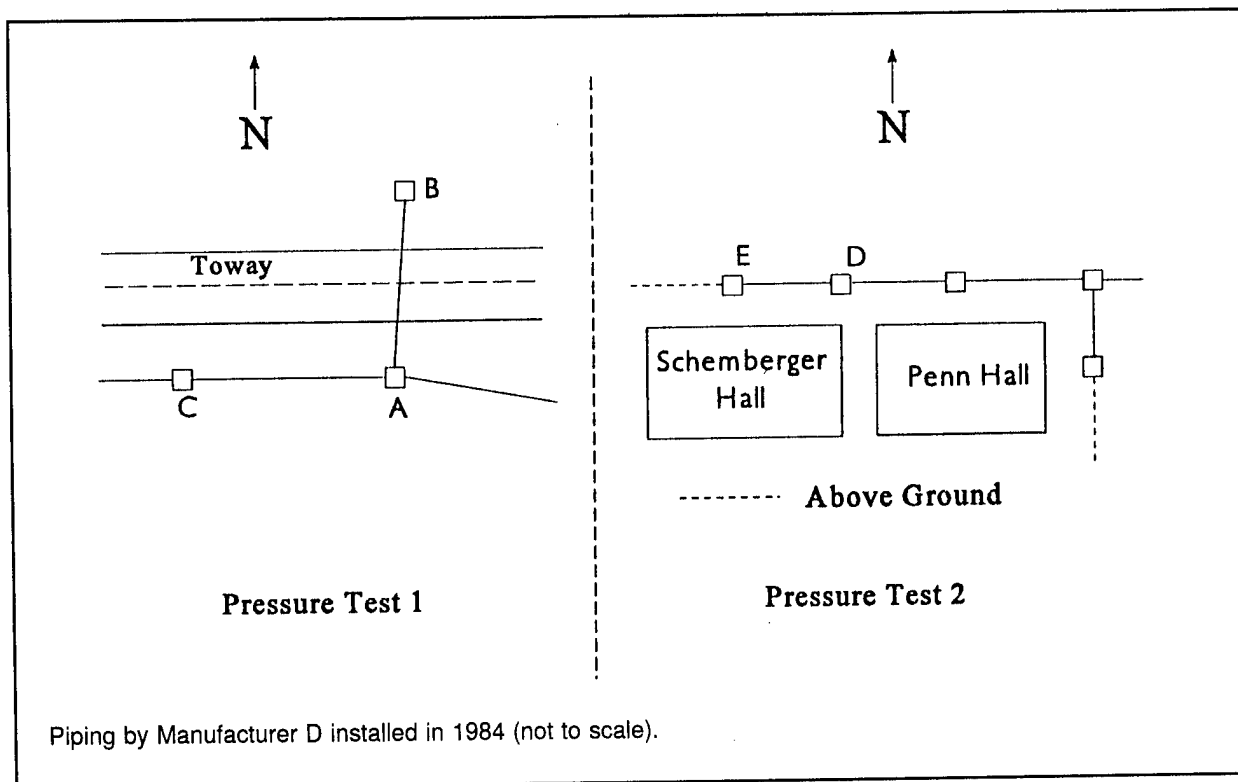
Figure N2. Schematic diagram of System 28 at Norfolk Naval Station, VA.

a. Pressure Test 1—This conduit section extended from Manhole A, described above, westward 170 ft to Manhole C. Manhole C was concrete with a concrete top flush with the parking lot pavement. The top had two access openings but no vent pipes. Manhole dimensions were 6 ft × 12 ft × 7 ft deep. Water was pumped out of this manhole and a portable fan was used to cool the manhole before entry. A gland seal was installed on the supply line at the manhole entry. The gland seal was tightened before pressure was applied to the conduit. One of the flanges on the dielectric flange assembly had been removed so the system was no longer electrically isolated. The conduit casing was 20-in. in diameter and contained a 12-in. steam line. Pressure to 15.0 psi was applied to the casing at 10:33 AM. Pressure readings were as follows:

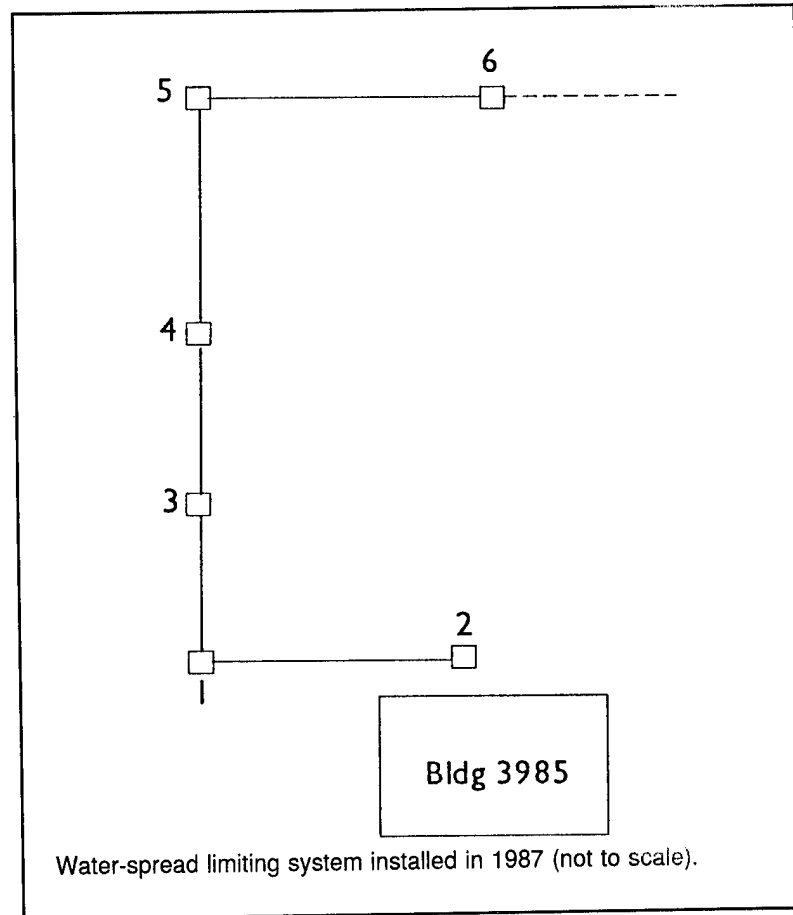
Figure O1. Schematic diagram of System 29 at Fort Lewis, WA.

This system is a 125 psi steam system with fiberglass return piping and was installed in 1984 (Figure O1). The steam supply uses a water-spread limiting system in which each section is sealed so that water cannot enter an adjoining section in the event of a pipe failure. The sections are joined with specially fabricated couplings with elastomeric rings that also serve as expansion-contraction joints. In Manhole 1, one of the conduits contained an end sleeve consisting of a rubberized plastic material bonded to the outer casing and extending to the heat carrying pipe. This material had dried out and cracked in two places and was very brittle in the area of the heat carrying pipe. This seal was not found on the ends of conduits at any of the other manholes. The lack of end seals exposes conduit insulation to water in the event of manhole flooding. Manholes inspected were as follows:

c. Manhole 3—Located 200 ft north of Manhole 1, this manhole was buried 2 ft below grade and was accessed through a 30-in.-diameter tube extending from grade to the manhole top. Manhole dimensions were 4 ft in diameter and 5 ft deep. Caulking at conduit wall penetrations was badly deteriorated.

f. Manhole 6—Located 300 ft east of Manhole 5, this manhole was concrete with top at grade containing two 6-in. ventilation pipes. Manhole dimensions were 5 ft × 7 ft × 8 ft deep. The water-spread limiting system ended at this manhole with the conduit extending 2 ft into the manhole with no end seal. The manhole was dry with a gravity drain. Exit from this manhole was with a steel-cased conduit that continues to Manhole 7 located 100 ft east of Manhole 6. Manhole 7 provides for transition from buried conduit to concrete trench.

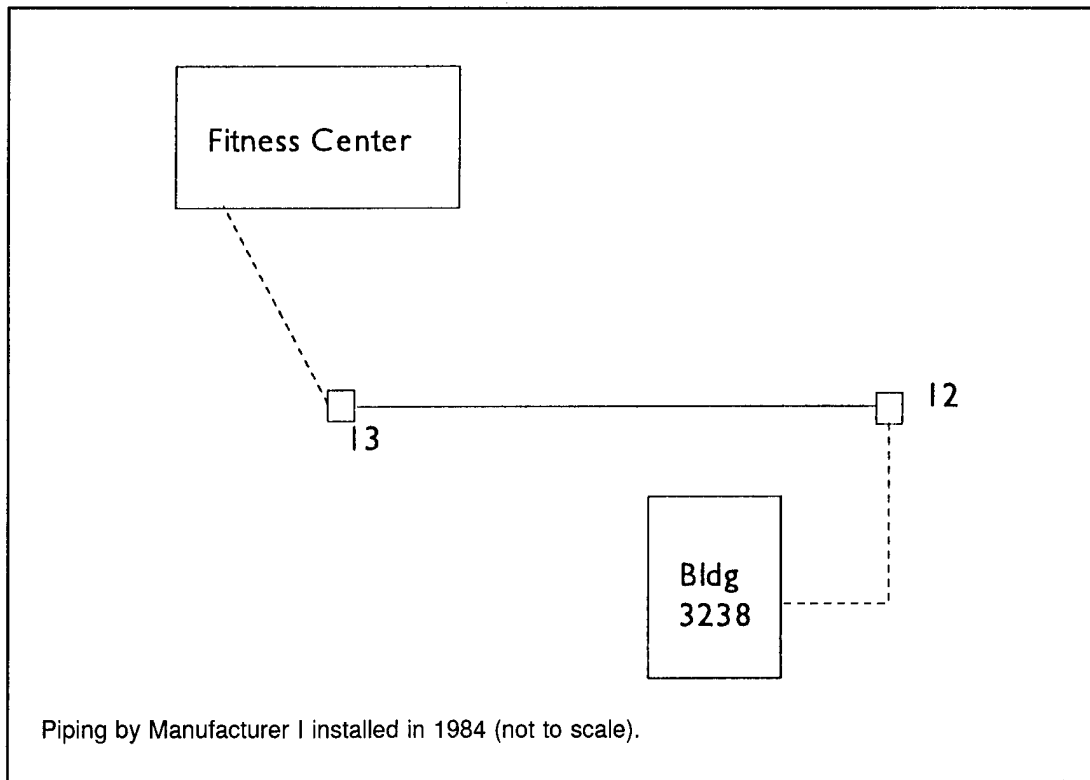
Figure O4. Schematic diagram of System 32 at Fort Lewis, WA.

(1) Manhole 12—This manhole was north of Bldg. 3238 and was concrete with concrete top at grade and dimensions of 7 ft x 7 ft x 8 ft deep. Manhole ventilation was provided by two capped 6-in. vent pipes. The manhole was dry at the time of inspection, and conduit wall penetrations were caulked and cemented. Access was through a 30-in.-diameter opening with a steel manhole cover.

(2) Manhole 13—This manhole was 500 ft west of Manhole 12. Construction was concrete with concrete top at grade containing a 3-ft square access opening with solid aluminum cover. Ventilation is provided by two capped 6-in. vent pipes. The manhole was dry at the time of inspection, and conduit wall penetrations were caulked and cemented.

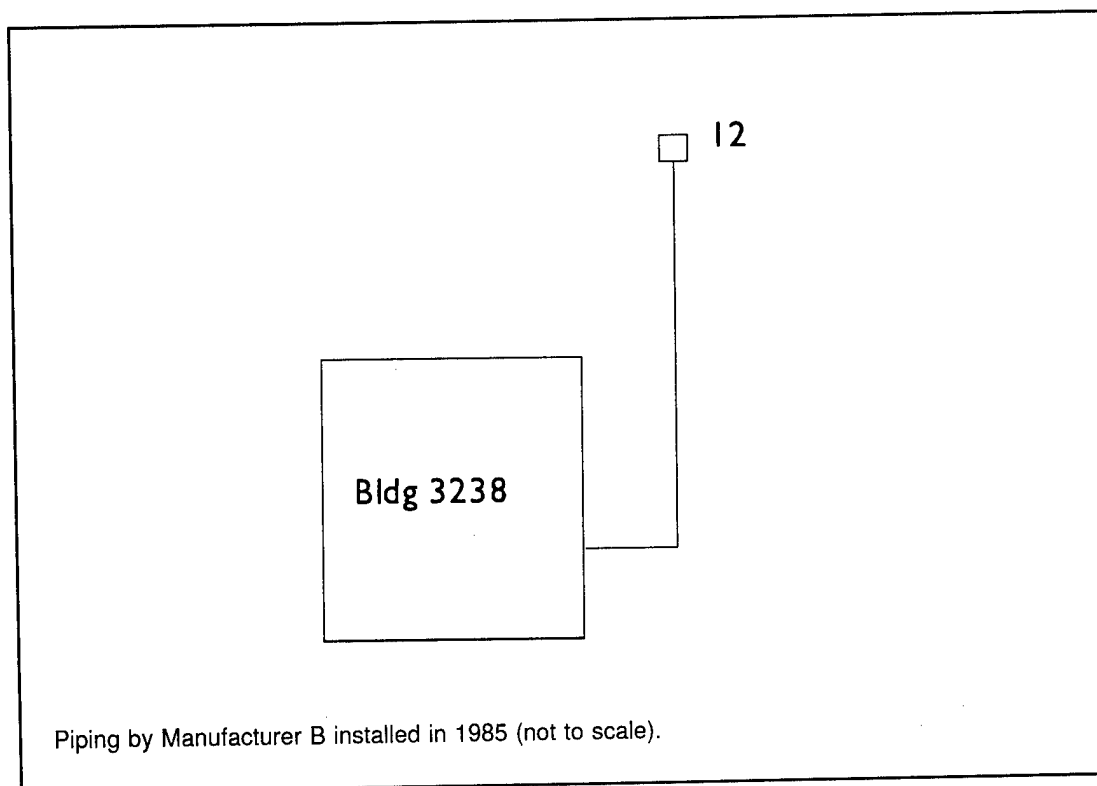
Figure O5. Schematic diagram of System 33 at Fort Lewis, WA.

(1) Manhole 12 to equipment room of Bldg. 3238—This run consisted of a single conduit casing enclosing both the supply and return piping. The conduit casing was 14-in. in diameter and each of the internal pipes were 4 in. Each of the 4-in. pipes have a gland seal at the end plate in the equipment room. The length of the conduit run is 180 ft. One of the gland seals in the equipment room could not be completely tightened and leaked slightly during the test. Pressure readings were as follows:
